**Honey Creek - Vigo Conservancy District
Vigo County, Indiana
Preliminary Evaluation of
District Plan**

January 2009

CBBEL Project No. 08-0454

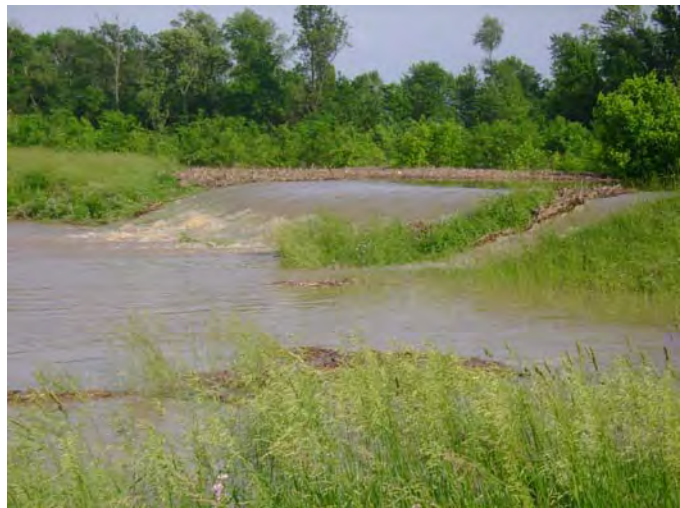
Figure 1: Overtopping of Honey Creek Levee near confluence of Jordan Creek

levee along the north side of Honey Creek at the confluence of Jordan Creek was also overtopped with the resulting floodwaters traveling northward before they were presumably captured by the Middle Channel. **Figure 1** shows the overtopping of a segment of levee on the north side of Honey Creek near the confluence with Jordan Creek.

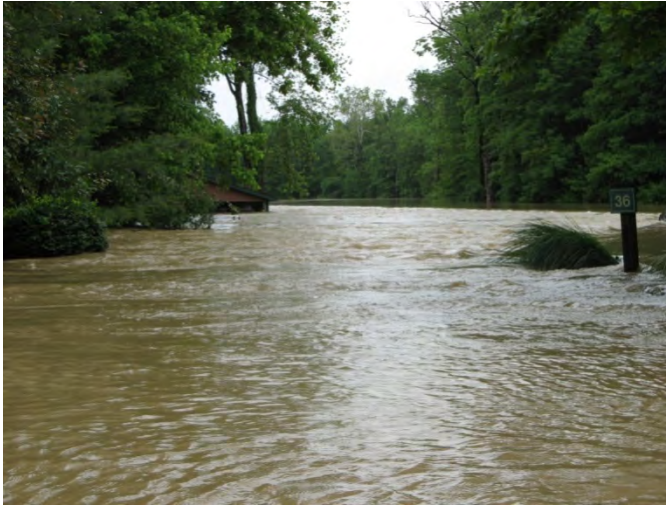
Figure 2: Floodwall overtopping from Corn Creek into Allendale Subdivision

back levee/floodwall system along Corn Creek to its east. The subdivision is bordered by natural high ground to its south and by US 41 to the west. As a result, Allendale effectively sits in a “bathtub” and relies on a pump station to discharge storm water over the levee into Honey Creek. At some point during the June 7th event, the floodwall segment along the Corn Creek tie-back levee began overtopping into the Allendale Subdivision because of high stream flows from Corn Creek (see **Figure 2**). The overtopping floodwaters quickly overwhelmed the pump station and filled the entire “bathtub” area of the Allendale Subdivision to the point where the flood waters from the subdivision began overtopping the levee to the north back into Honey Creek. Nearly the entire subdivision, approximately one dozen homes, was inundated by as much as 8 feet of water as a result of the flooding. Operations problems with the pump station resulted in the homes remaining inundated for several days. Refer to **Appendix 2** for additional photographs of the Allendale Subdivision flooding.

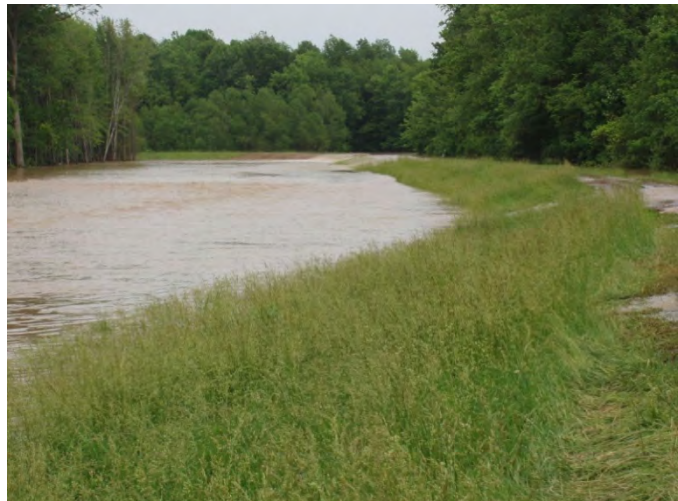
Figure 3: Overtopping of levee on north bank of Honey Creek at RM 11.0

A segment of the levee along the north bank of Honey Creek between the confluence of Corn Creek and the UNT to Honey Creek (approximately RM 11.0) also experienced overtopping (see **Figure 3**). The overtopping floodwaters began to flow north towards Thompson Ditch. Many homes and businesses within the area bounded by Honey Creek to the south, US 41 to the west and Thompson Ditch to the North were damaged by floodwaters which presumably resulted, at least in part,

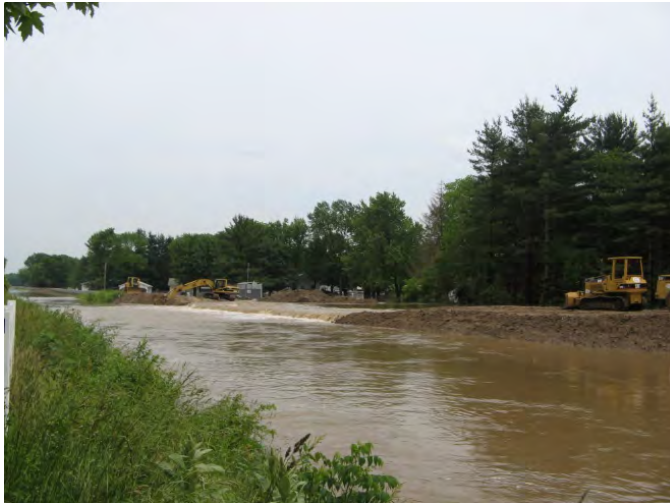
Figure 4: Flow entering south side of Thompson Ditch at 5th Street

from the overtopping of this levee segment. Although flooding in this area was severe, two factors helped to lessen both the severity and duration of the flooding. The first factor was that flows in Thompson Ditch were much less than flows in Honey Creek due to the fact the Thompson Ditch watershed extends mainly to the north. Secondly, the segment of levees/floodwalls on the south bank of Honey Creek to the east of 7th Street were under construction at the time of the flood and a large gap in the line of protection at 5th Street actually allowed floodwaters

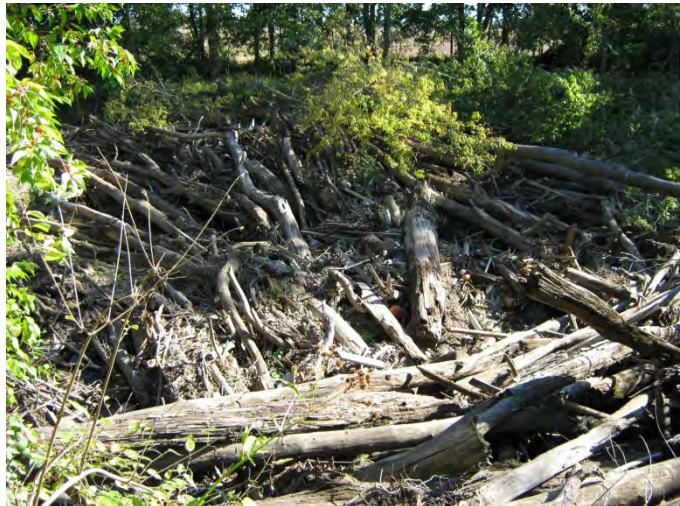
Figure 5: Logjam in channel of Honey Creek

Several significant logjams were observed at the time of the field investigation. Mr. Adams indicated that while the logjams may have moved slightly during the June event, they definitely existed prior to the June event. It was Mr. Adams opinion that the logjams may have been a major factor in the severity of the June flooding. Figure 5 displays one of the logjams observed during the field investigation.

9. Remove the logjams from Honey Creek and implement a program, including funding mechanisms, to continuously inspect for and promptly remove all future logjams. The District should consider partnering with the County and/or NRCS to develop their logjam removal program and determine appropriate responsibility of parties involved.
10. Only after completing analyses recommended above, proceed with the design and construction of the remaining flood control components recommended by the District Plan. The order that the remaining components are constructed in should be evaluated based on a determination of which remaining components will provide the most benefit.

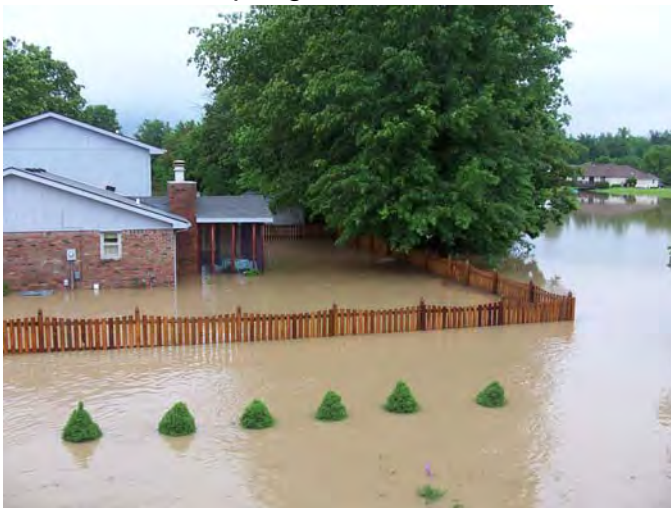
Figure 6: Flooding in Willa Villa from adjacent pond (taken at 10:45am on June 7th)

In the 2008 flooding, the moderate intensity rainfall that had occurred in the weeks leading up to the June 7th event left the pond at well above normal levels. The rainfall and levee overtopping of June 7th caused the water surface elevation of the pond to increase even further which quickly inundated most of the homes and streets in the neighborhood. **Figure 6** shows a view of the flooding in the neighborhood during the June 7th event. In the photograph, the pond area can be seen as the large open area at the far right of the picture. Following the June 7th event, the pond took an excessive amount of time to return to its normal water surface elevation. Photographs provided by one homeowner show the pond remained above normal for at least a month following the June 7th event.

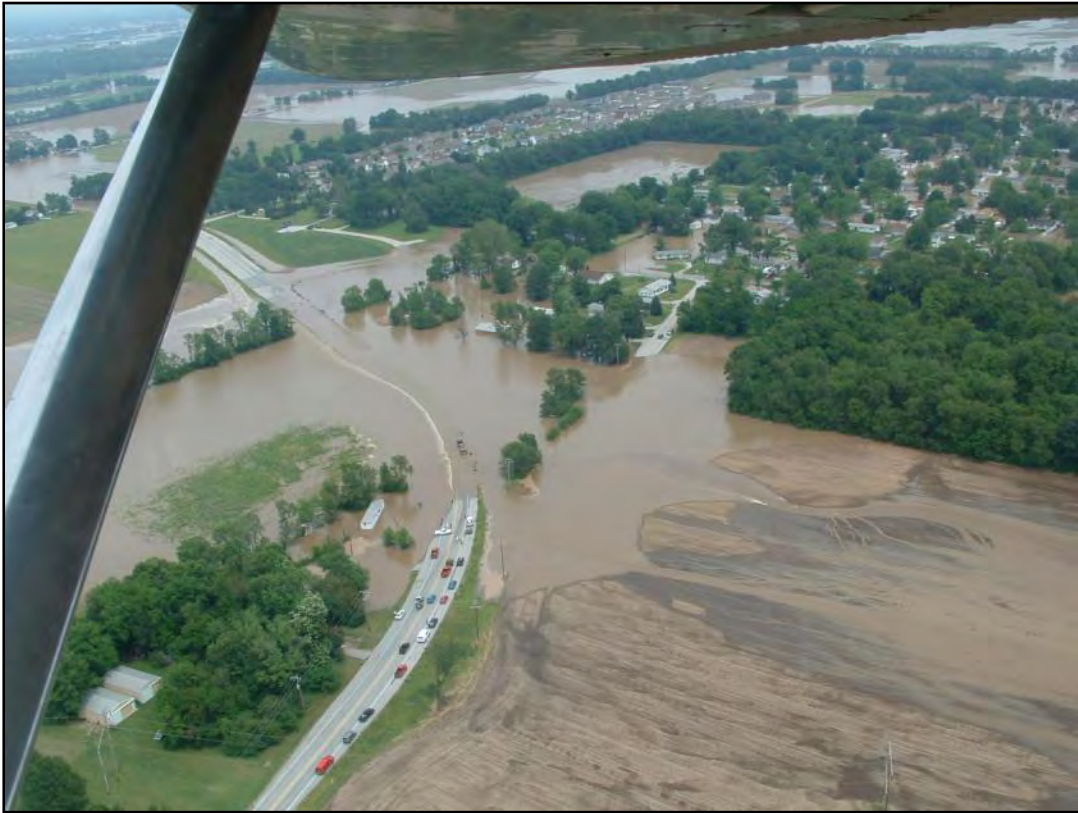
Photo 1: Aerial photograph of flooding of Honey Creek of SR 63.

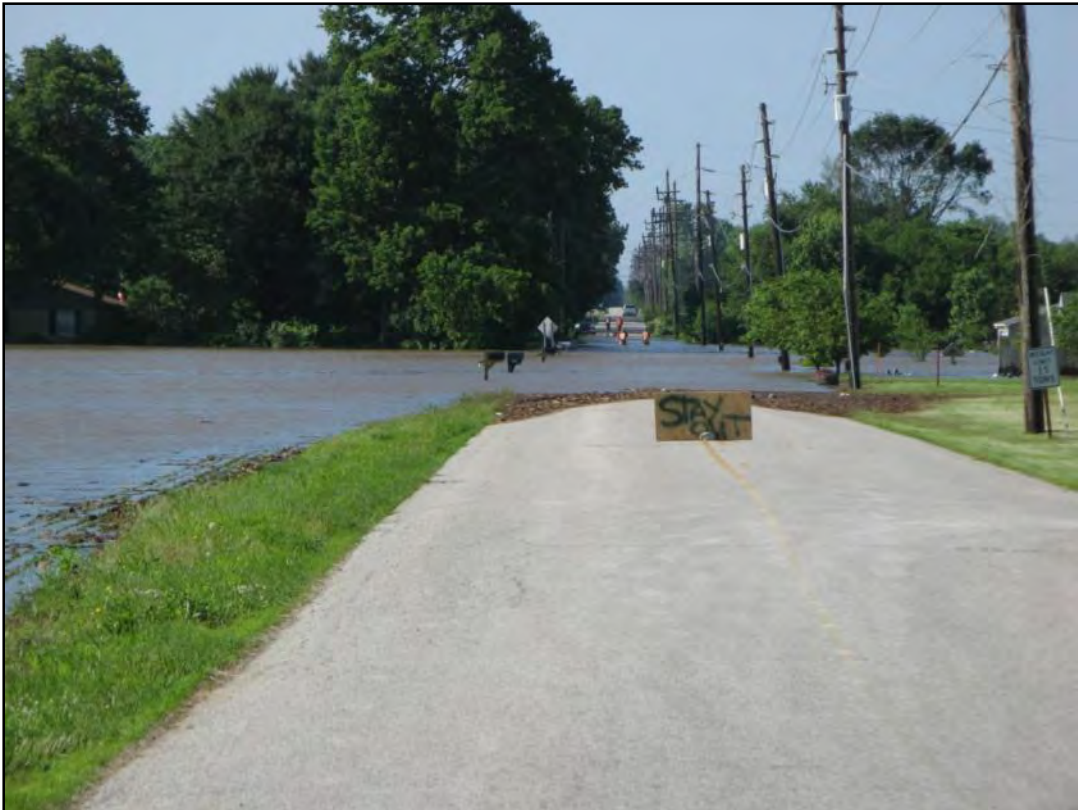
Photo 2: Flooding of a neighborhood near Honey Creek downstream of SR 63

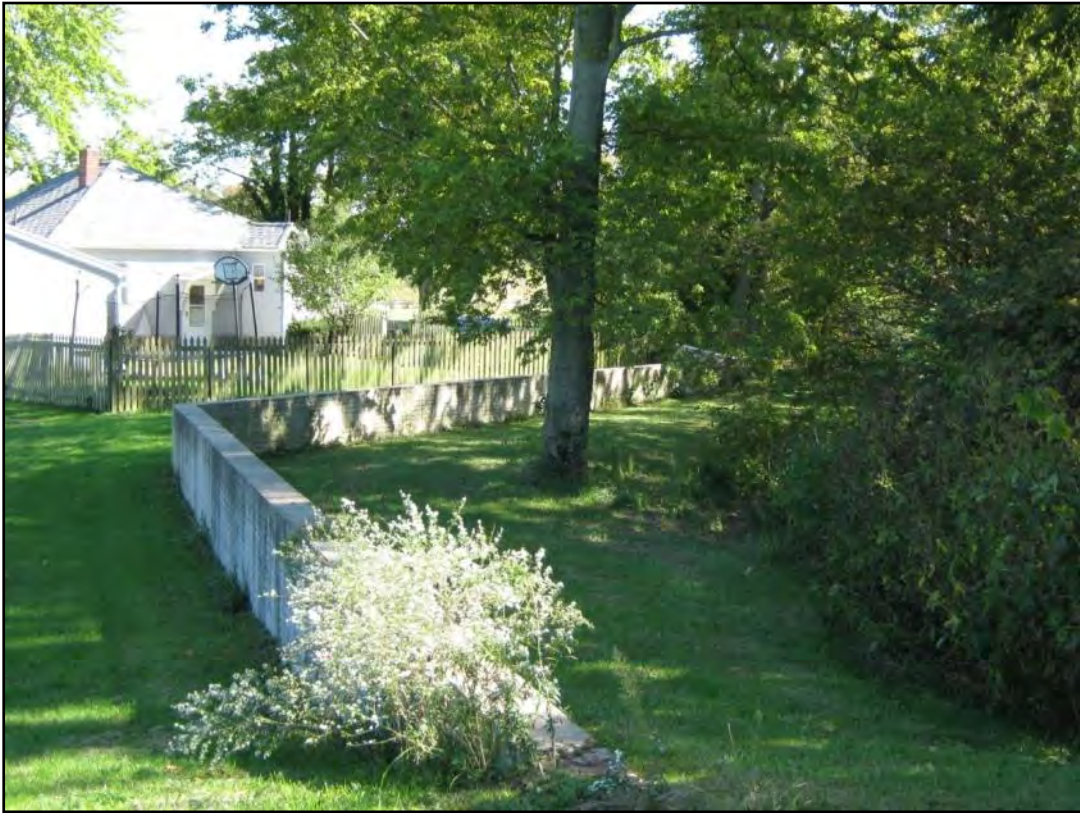
Photo 3: Looking along floodwall just west of the confluence of Jordan Creek and Honey Creek near Rigney Road during October 9, 2008 CBBEL site investigation.

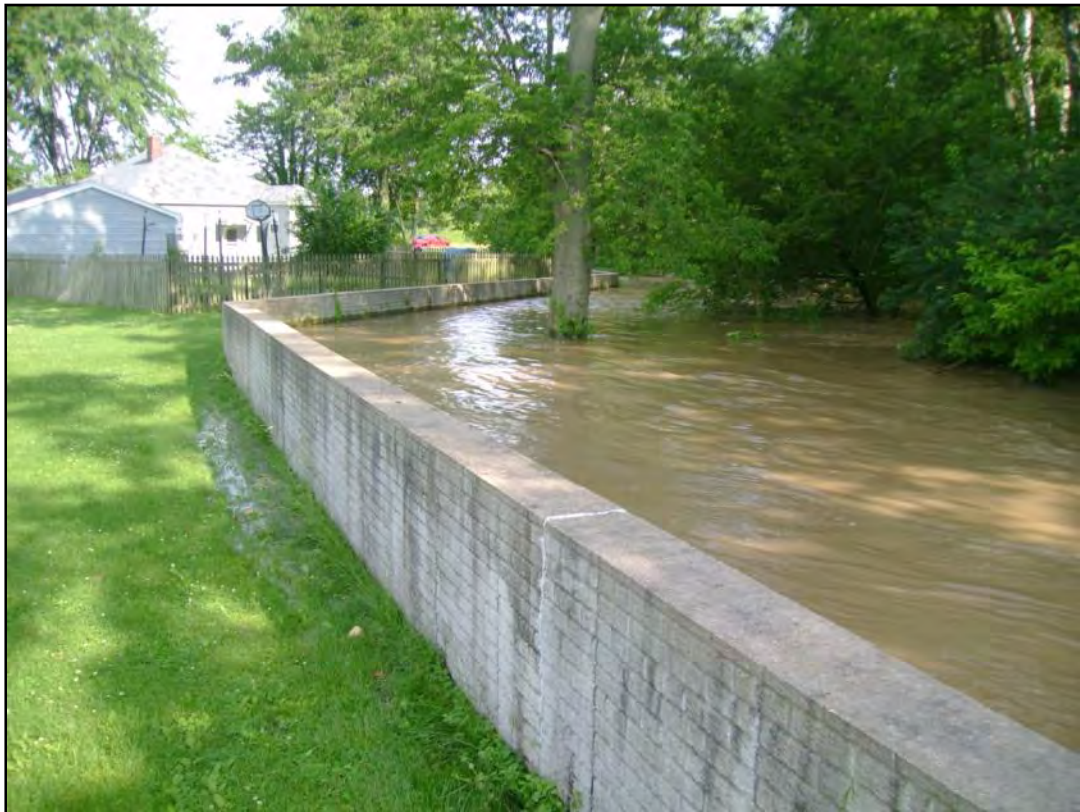
Photo 4: Looking at floodwall shown in Photo 3 during June flood event.

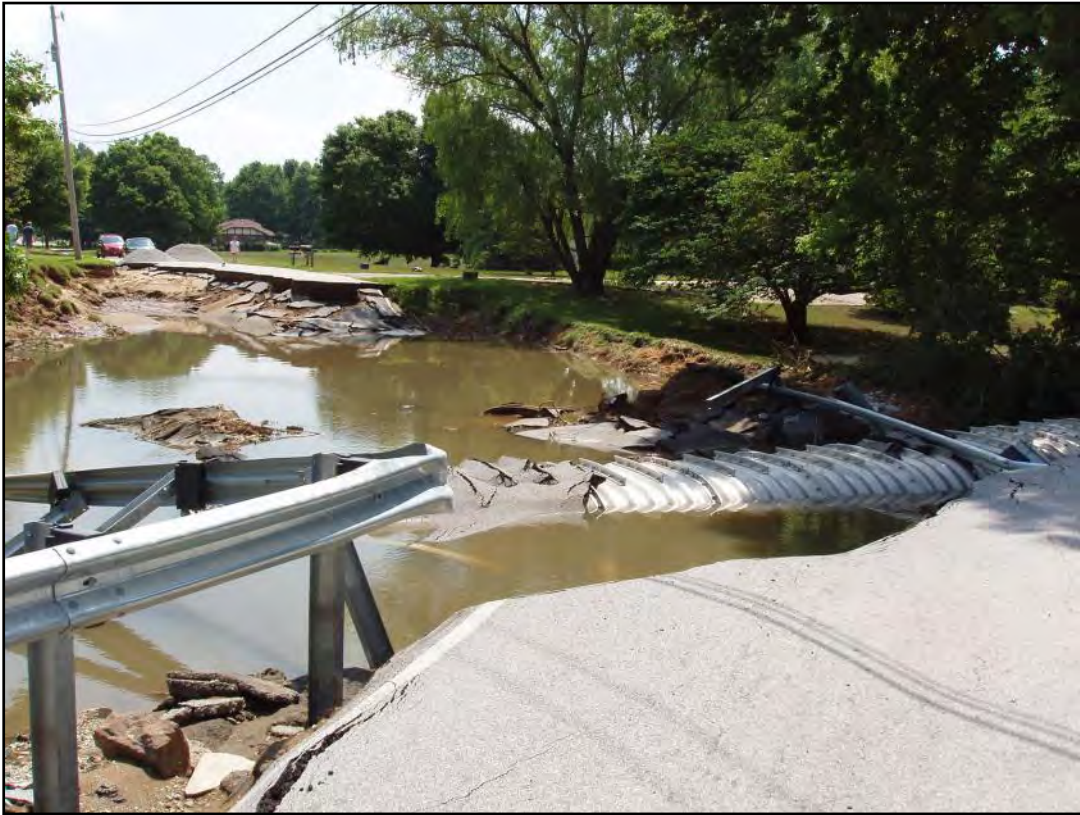
Photo 5: Looking at culvert washout from Jordan Creek Overflow.

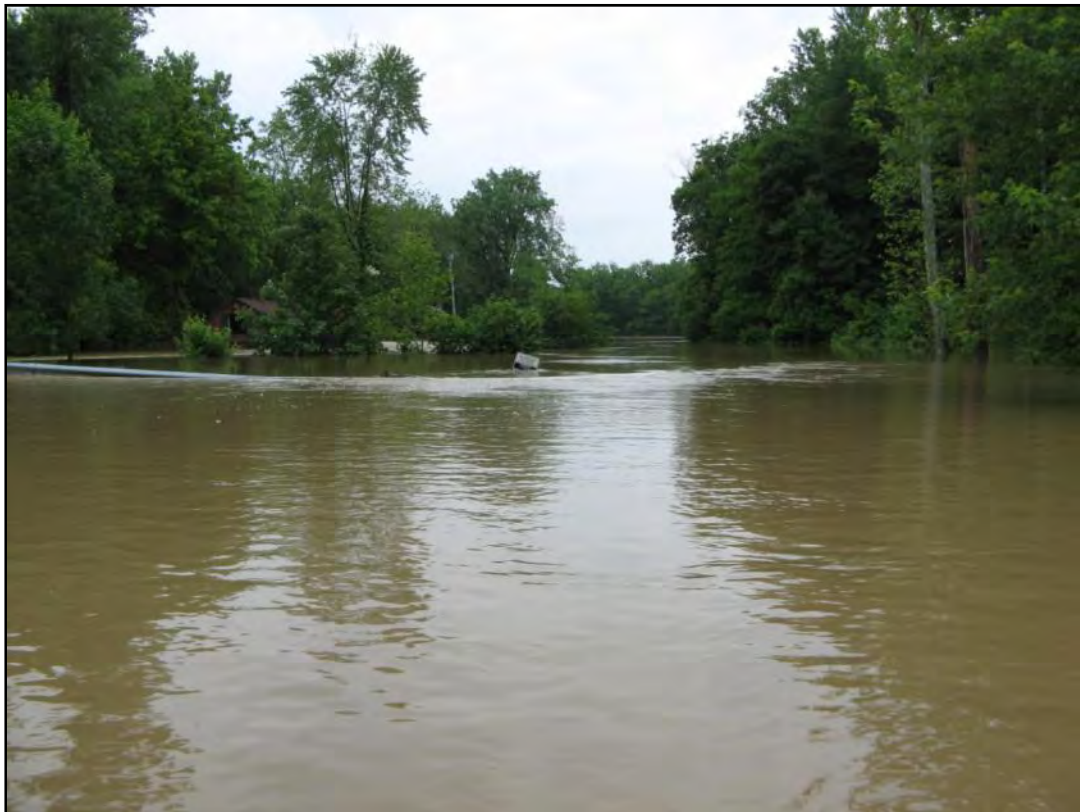
Photo 6: View of Allendale homes being flooded by Corn Creek. Floodwall is being overtopped in foreground of photograph.

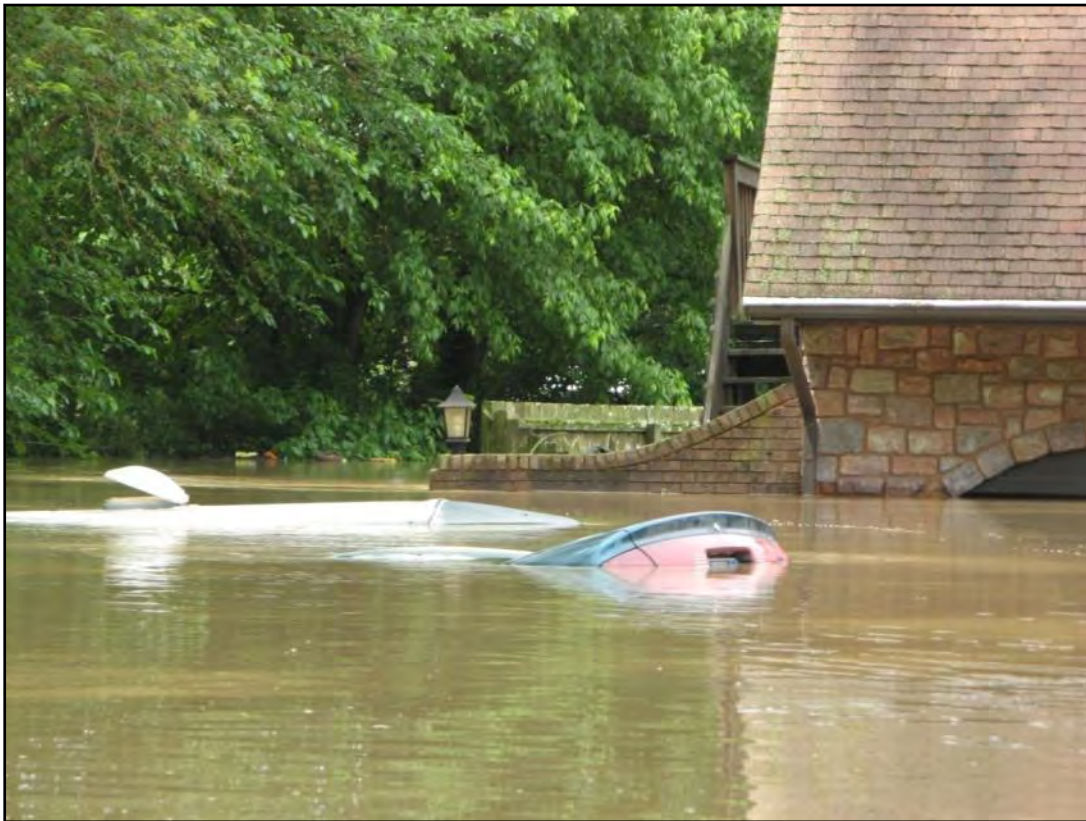
Photo 7: View of car in Allendale neighborhood with inundated home in background.

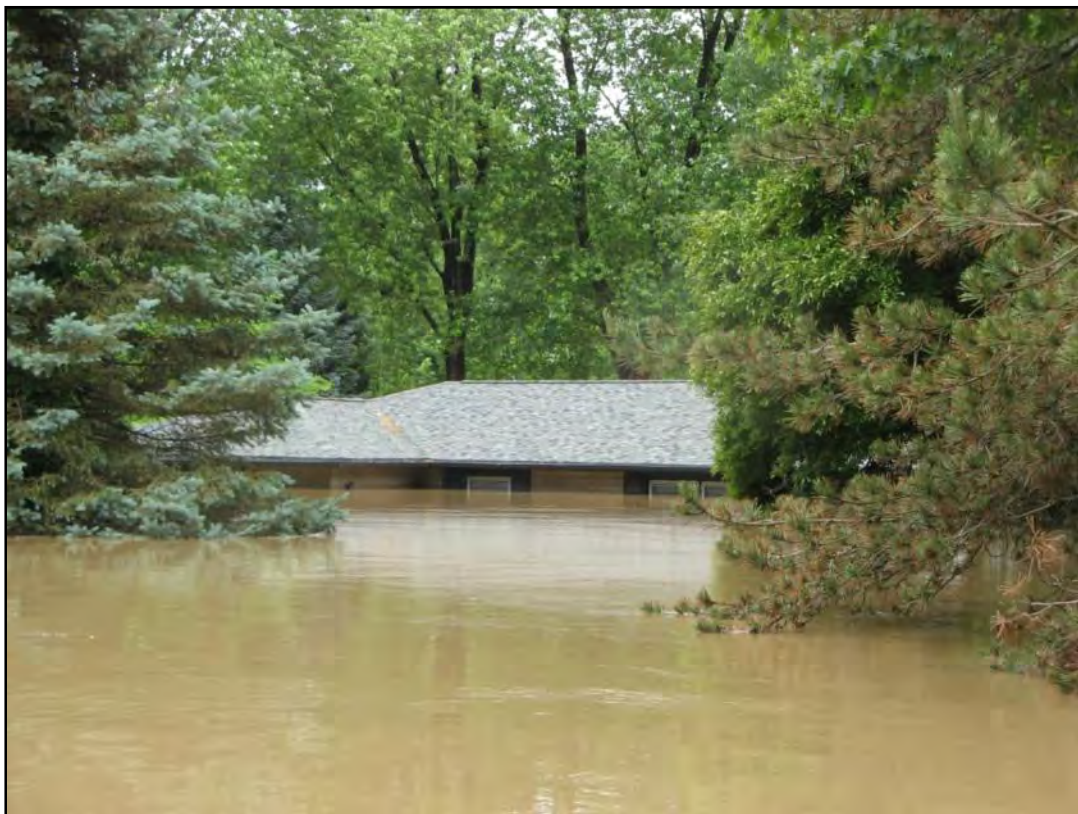
Photo 8: View of home flooded in Allendale neighborhood.

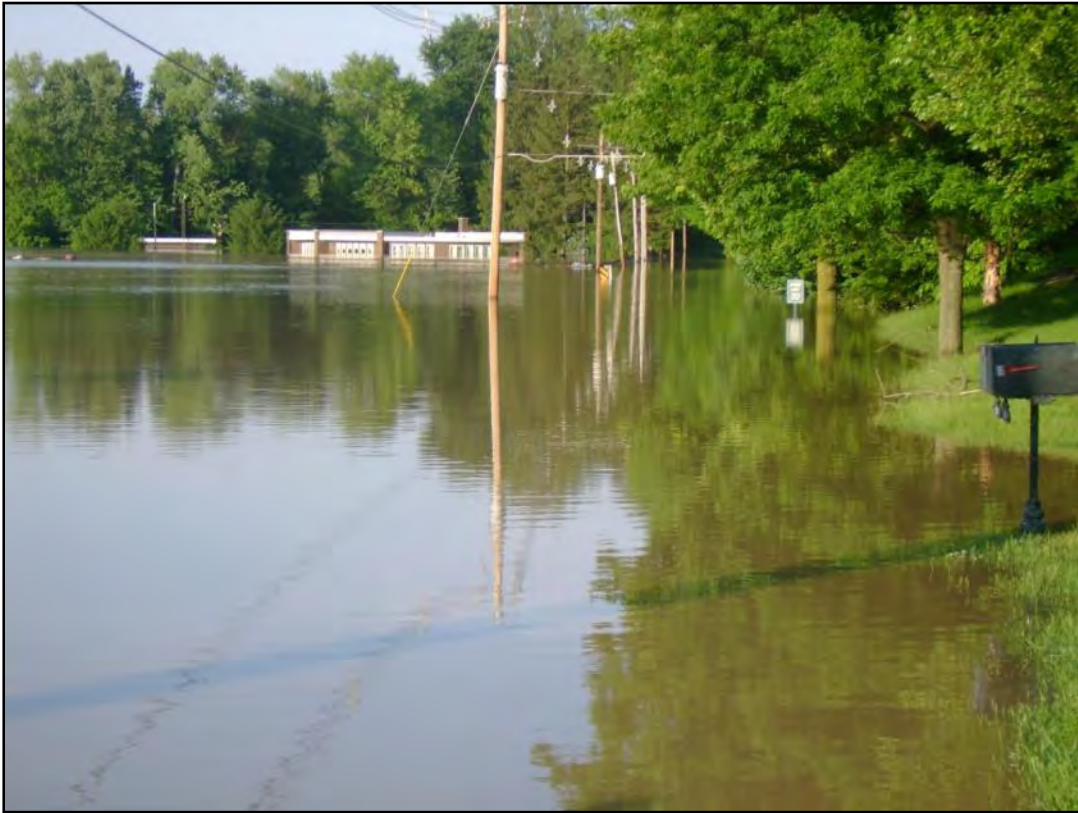
Photo 9: Looking north towards home just south of Honey Creek near Allendale neighborhood.

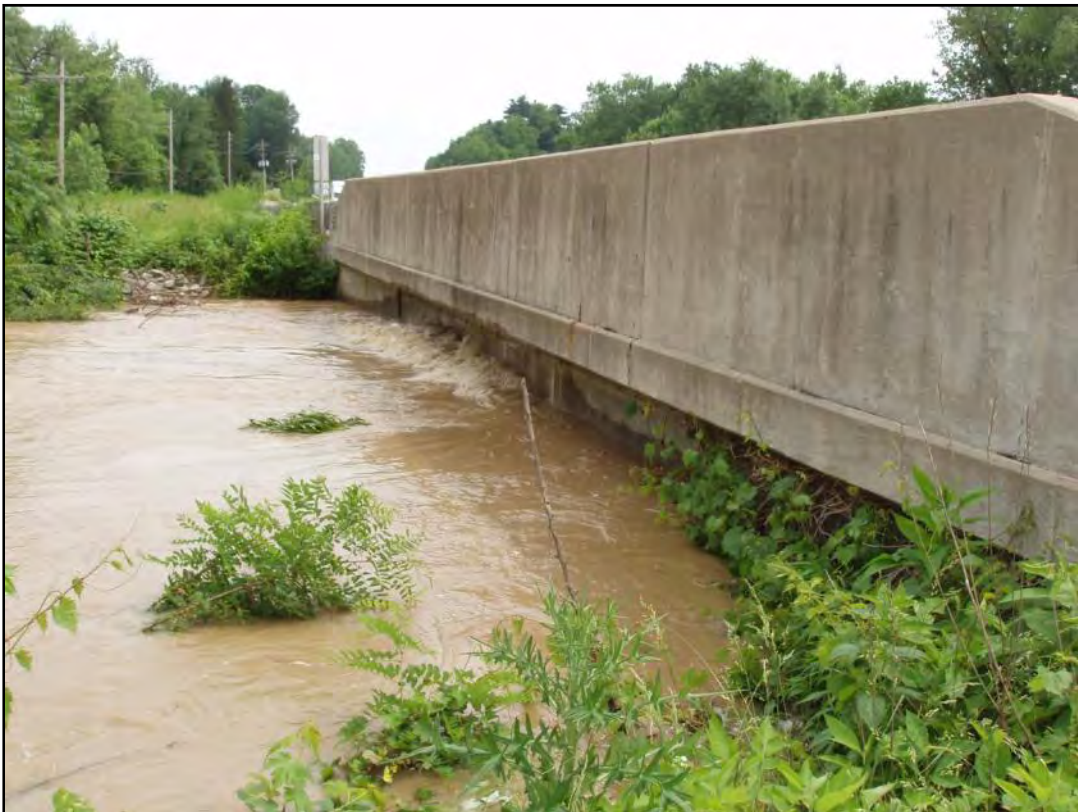
Photo 10: Looking south from levee towards the US Highway bridge over Honey Creek.

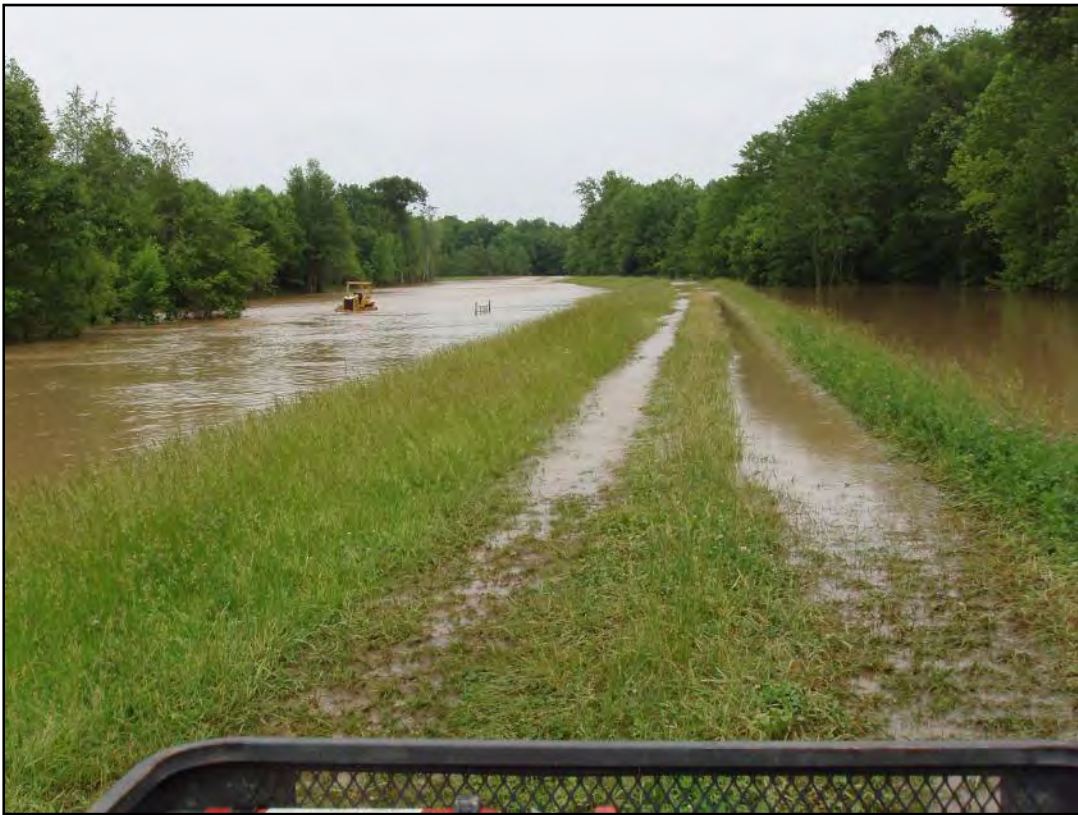
Photo 11: Looking east along levee north of Honey Creek (RM 11.0). Levee is overtopping in background.

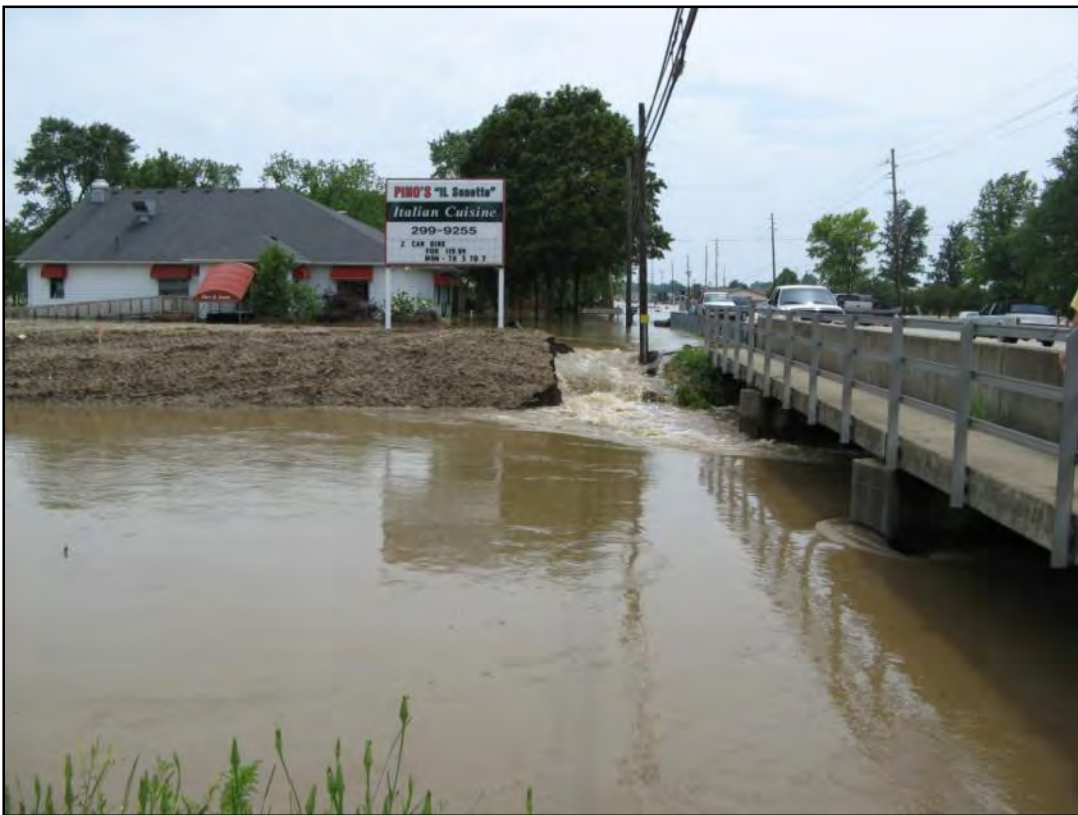
Photo 12: View of levee culvert blowout just east of 7th Street.

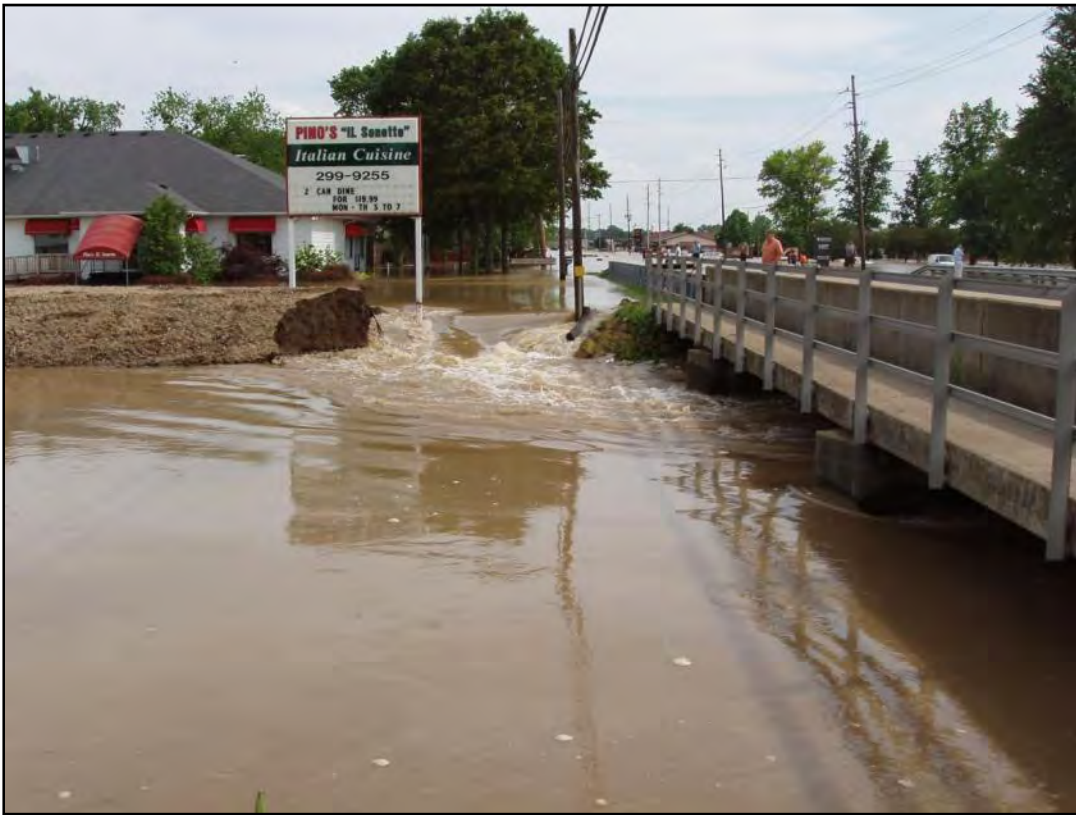
Photo 13: Photo of levee culvert blowout just east of 7th Street taken after significant erosion has taken place.

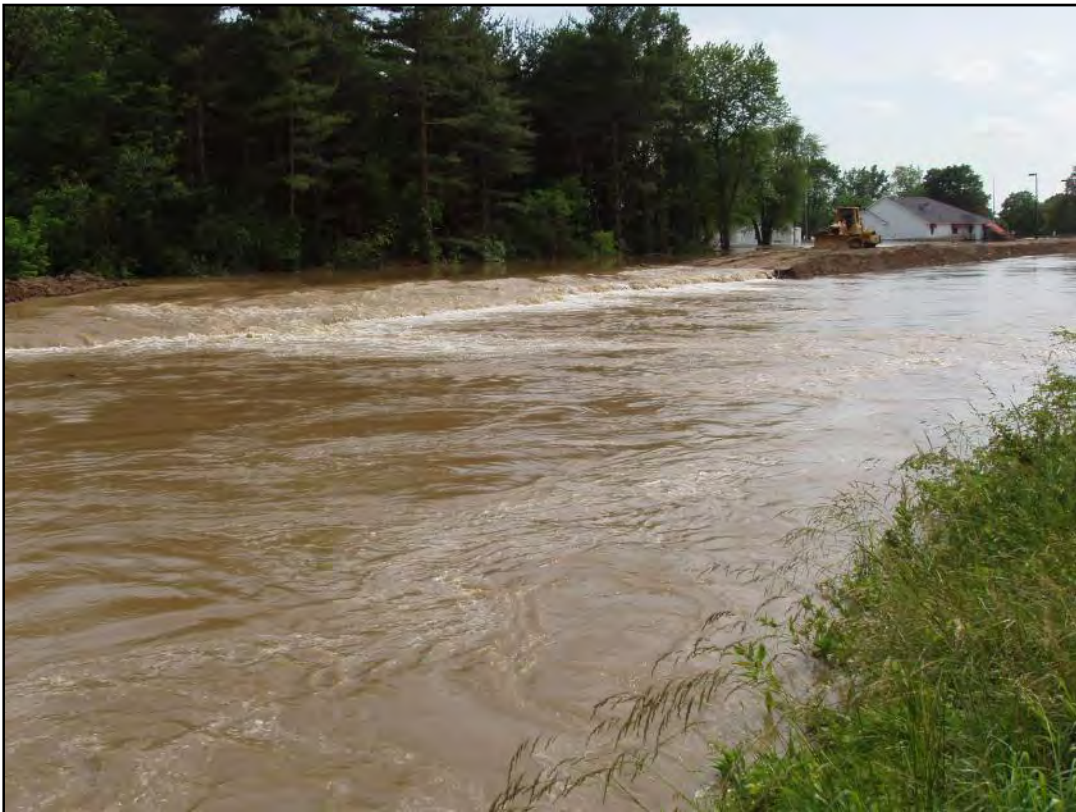
Photo 14: Floodwaters from Honey Creek discharging into Thompson ditch through gap in floodwall.

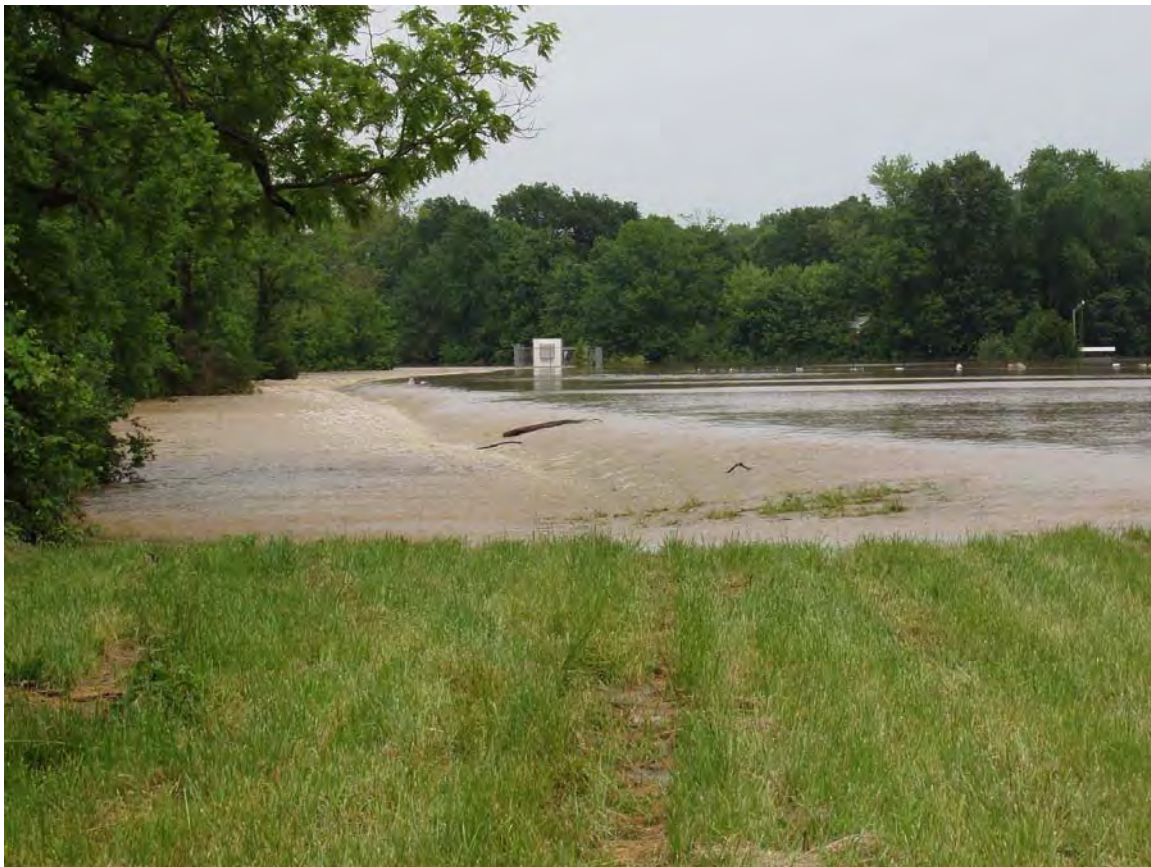
1. Allendale - Overtopping of the west end of the dike from the protected side moving over the dike and into Honey Creek. Picture taken at 3:17 p.m.

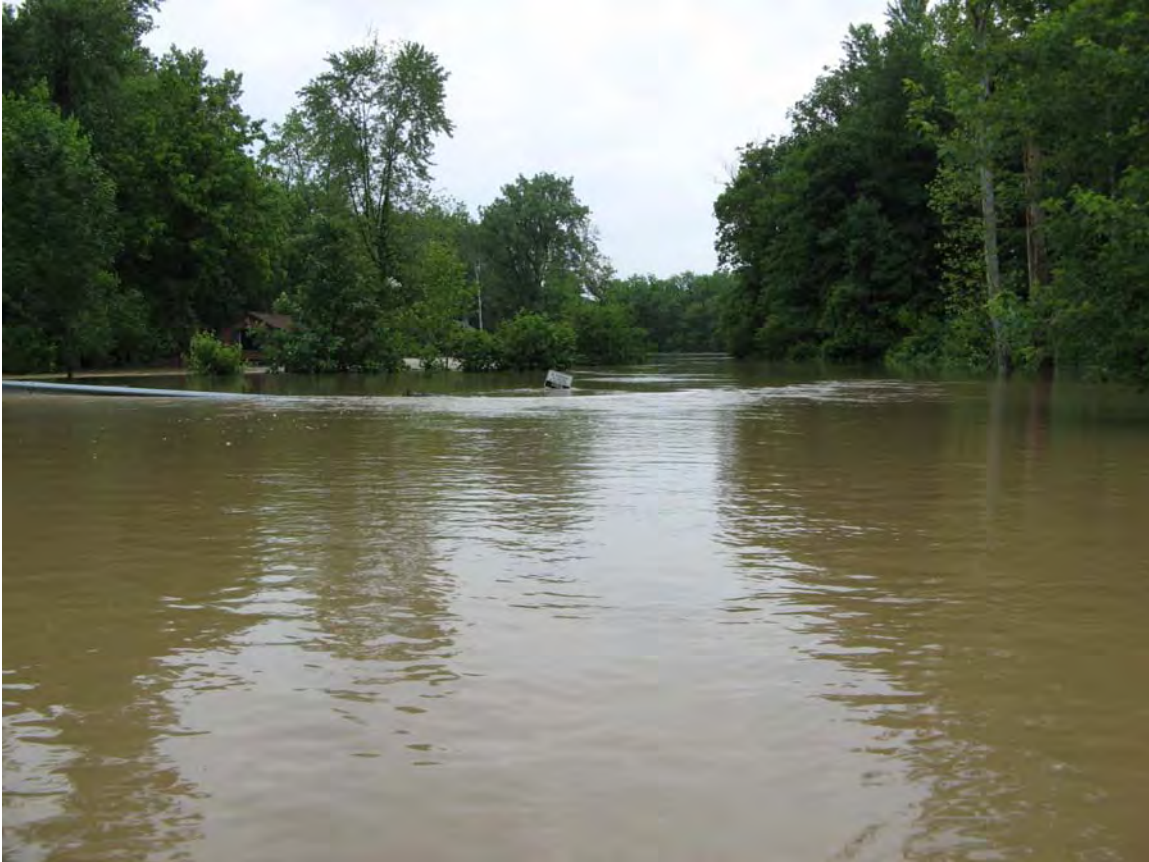
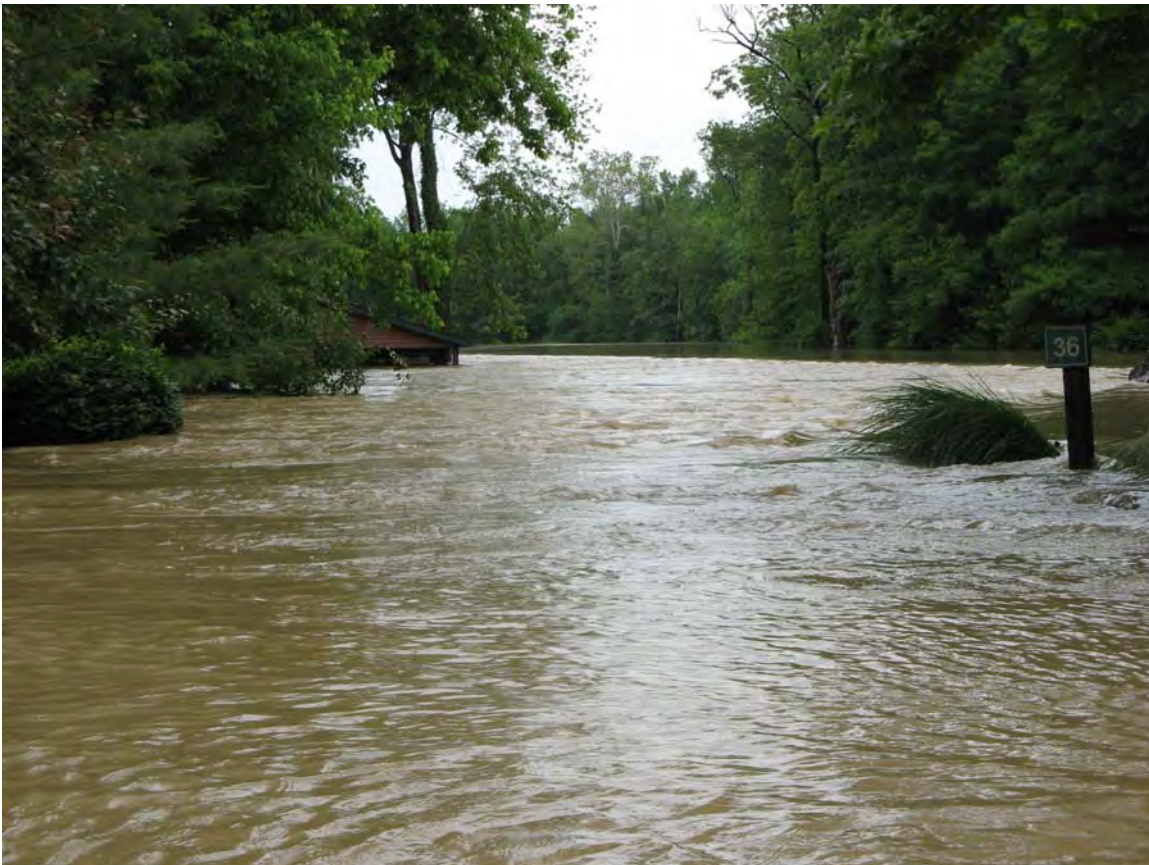
2. Allendale at Country Club Road and Corn Creek overtopping the guard rail and concrete floodwall. Pictures taken by Eddy Adams by kayak around late a.m.

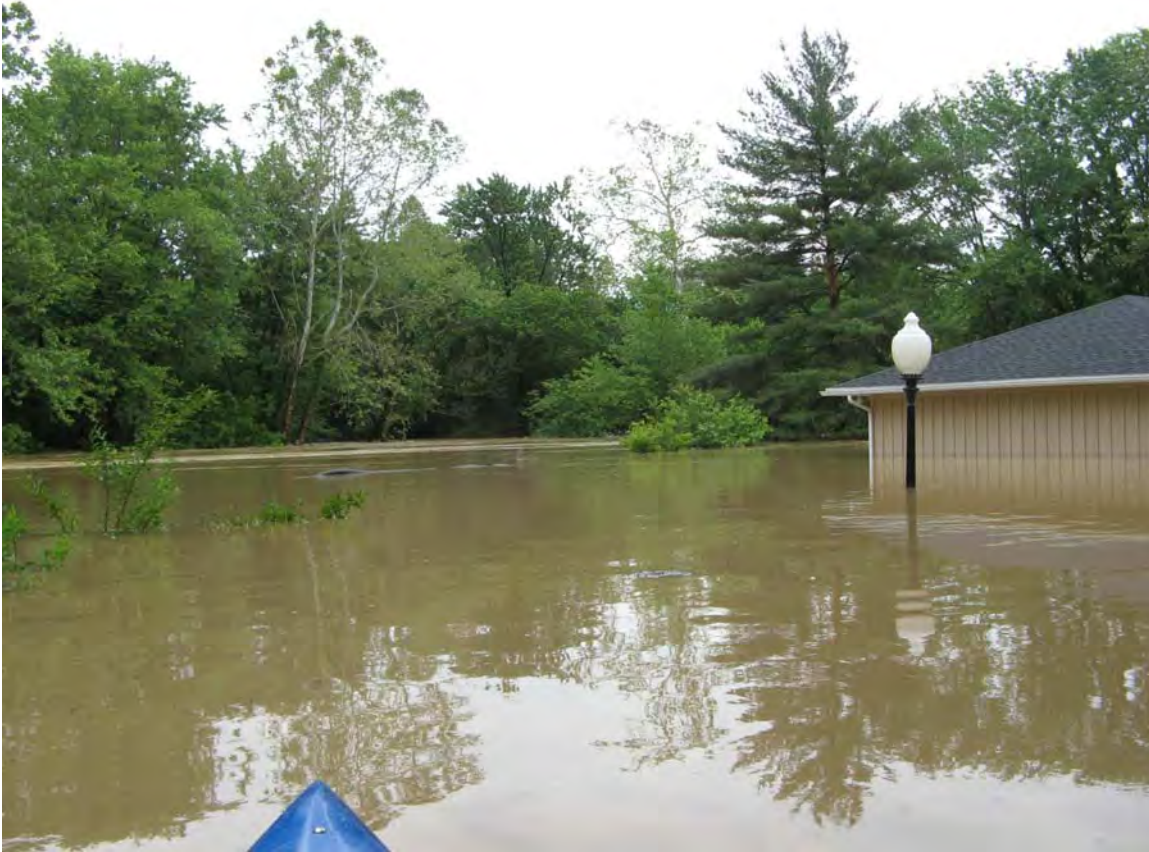
3. Allendale just downstream confluence of Honey Creek and Corn Creek overtopping concrete floodwall along Honey Creek. Picture taken by Eddy Adams by kayak around late a.m.

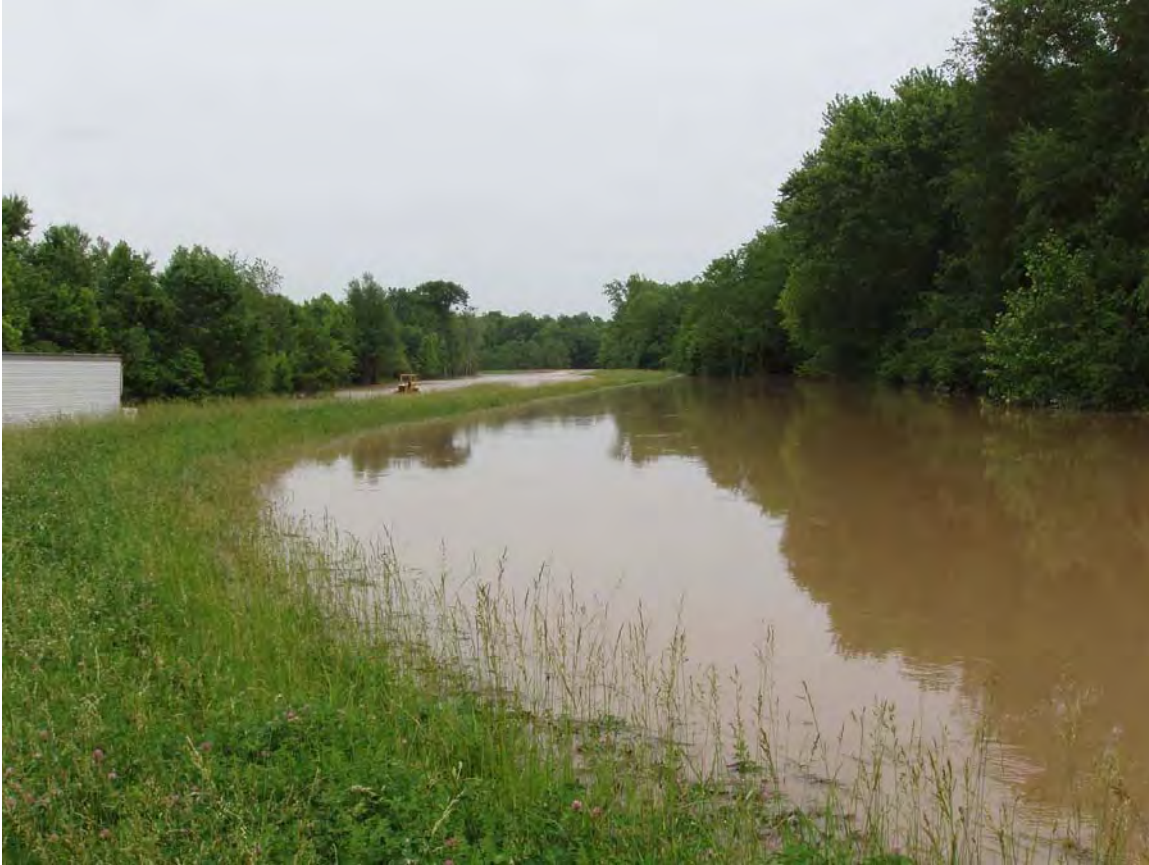
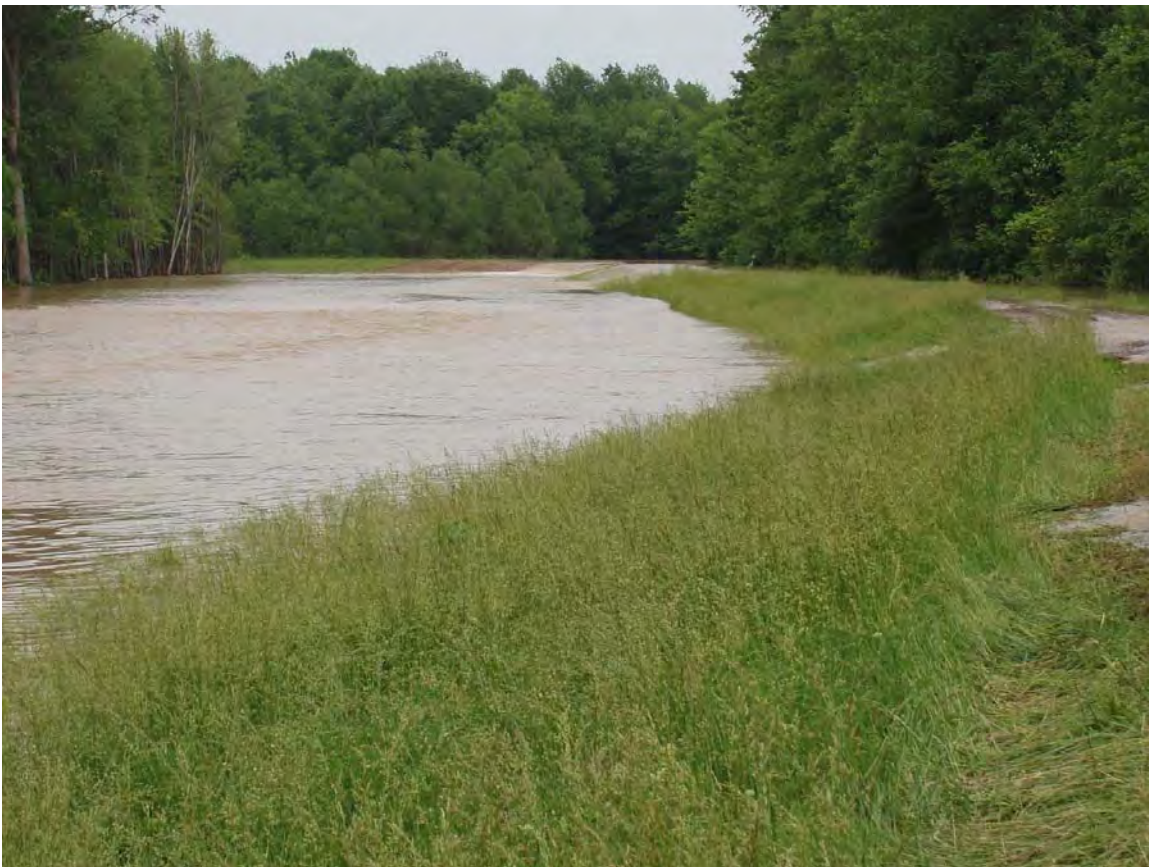
4. Honey Creek floodplain north of creek and east of US41 near twin 36" dia pipes looking upstream (east). Note overtopping in foreground. Picture taken at 3:43 p.m.

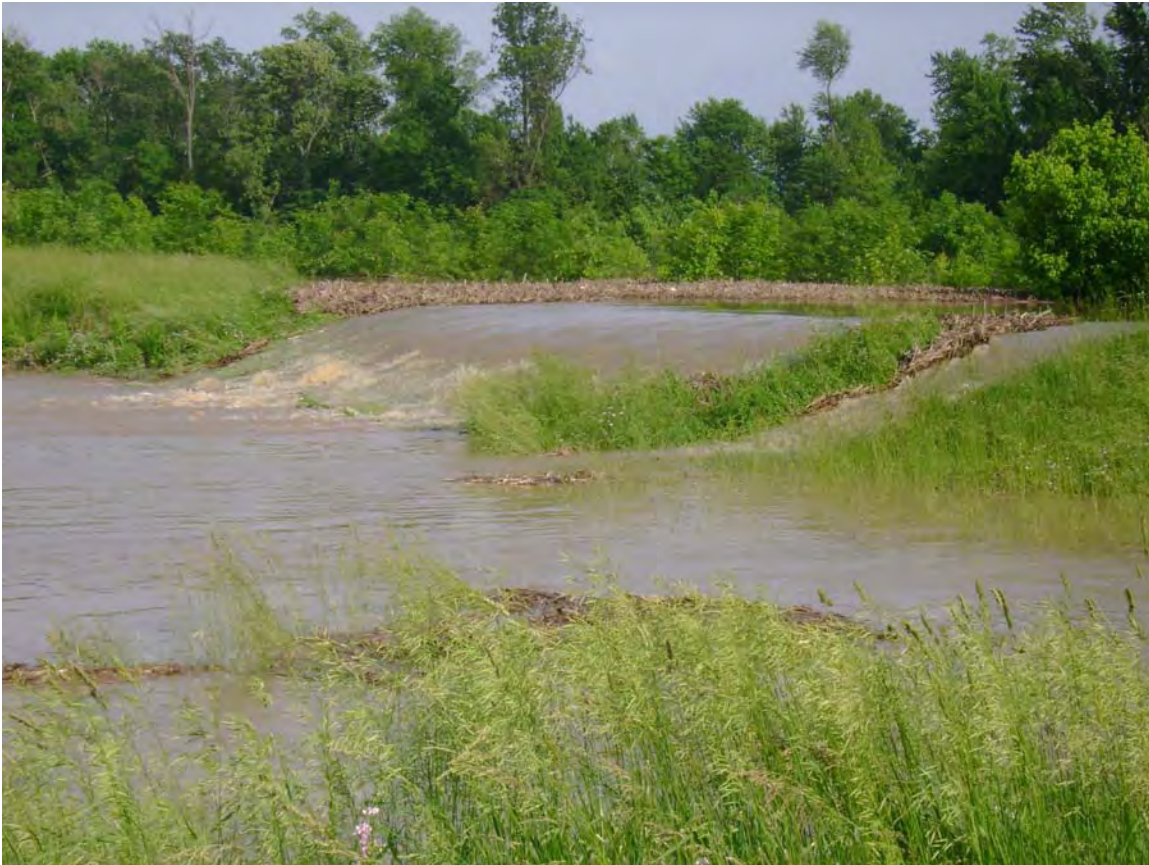
Honey Creek was overtopping the dike north of the creek and east of Rigney Road as well as the majority of what we call the Jordan Ditch Dike. There was damage but no overtopping of the Honey Creek dike to the west of Sullivan Place/Rigney Road.
